Accident at Hither Green Station

No: IGS 252

Infrastructure Group Safety Bulletin

Accident at Hither Green Depot.

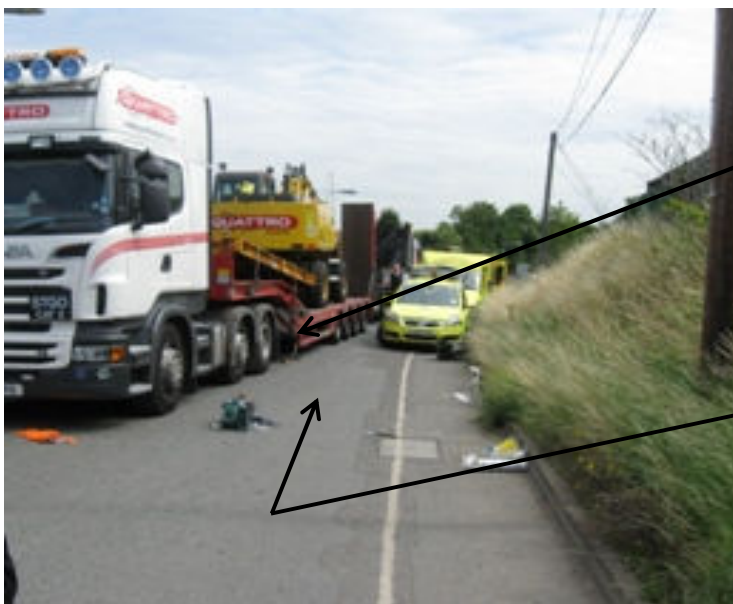
Fig 1:- Site of the Accident

The injured person was working at this point.

This is the scene after the injured person has been removed to Hospital. This is also the view the driver would have had as he left the depot approaching the stationary low loader.

From marks at the scene, it is believed the front offside wheel mounted the kerb, onto a grass verge.

It is believed the rear wheel failed to follow the front and was constrained by the kerb. It is believed the rear of the moving lorry crushed the injured person against his lorry.

- 1. All employees and contractors are to be briefed on the circumstances of this accident and reminded of the risks in and around depots and access roads from moving vehicles.**
- 2. All employees must consider and implement a safe system of work when working on the off side of a vehicle on the public highway.**
- 3. When using Road Rail Vehicles, all employees must consider the arrangements in place for delivery/collection of the Road Rail Vehicle.**
