Infrastructure Safety Bulletin 250

Croydon DU – Track Worker Struck by Train – Re-brief

Infrastructure Group Safety Bulletin

Croydon DU – Track worker struck by train

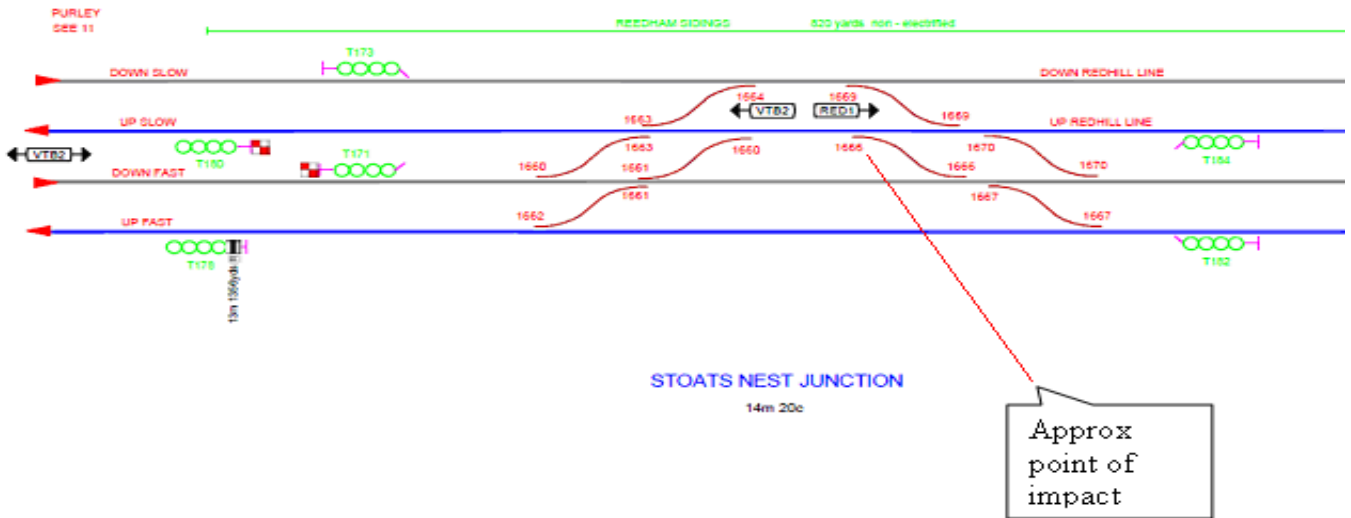
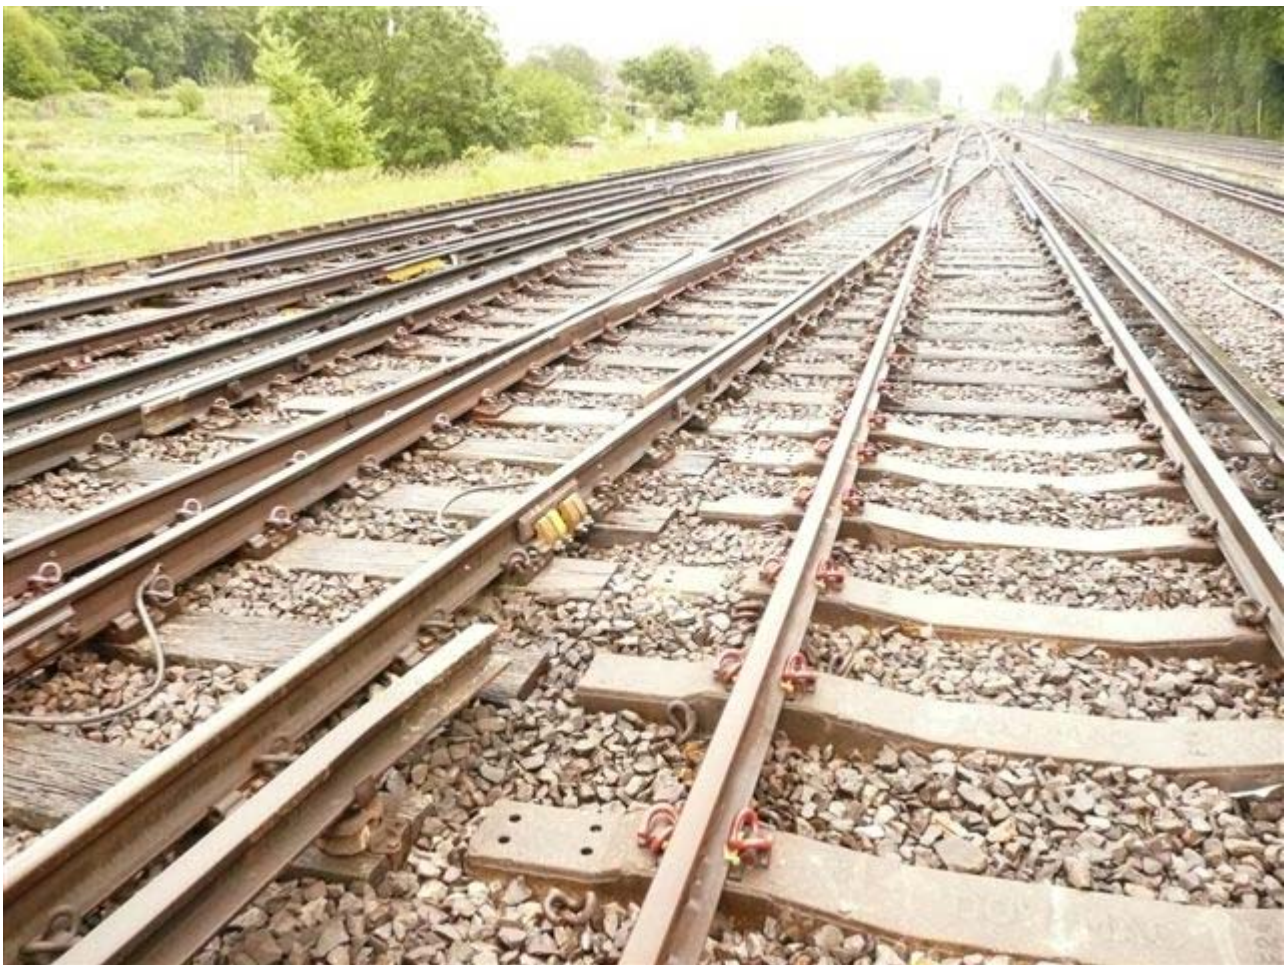
At approx. 05:31hrs on Sunday 12th June, 2011 a member of maintenance staff was struck and severely injured by a train.

The Injured Person (IP), an Assistant Section Manager for the local track section, together with his Track Section Manager and a team of track staff, were undertaking pre-planned track maintenance in the vicinity of T1666 points at Stoats Nest Junction, Purley.

During the course of the part two possession, the team were installing a closure rail between the A and B ends of T1666 points. For reasons that are not currently understood, the rail planned to be used was of insufficient length and the team had to source a longer rail to complete the works. It is understood that this delayed the progress of the planned works.

The below diagrams show the layout of the site and the location of the accident. At this stage in our investigations it is not possible to state the cause(s) however; the immediate investigation is centered on the activities being performed, proximity of the adjacent Up Redhill line that had earlier been re-opened to traffic and the planned and actual methods of protecting staff from movements on the adjacent line

- All employees who work on and around the track are to be briefed on the circumstances surrounding this accident before commencing their next shift.
- During the briefing employees should be reminded of the need to be vigilant when on and around the track and to know their position of safety at all times
